RE: SR 527 132nd St. SE to 112th St. SE Widening Shoreline Enhancement and
Floodplain/Wetland Mitigation Sites
USACE NWP (14) 200200046

The Washington State Department of Transportation completed qualitative monitoring of SR 527 Widening mitigation site on July 30, 2014, to address Final-year (2016) performance standards. Monitoring activities included vegetation observations and photo documentation. This Year-8 report is being issued for documentation of early achievement of Final-year performance standards.

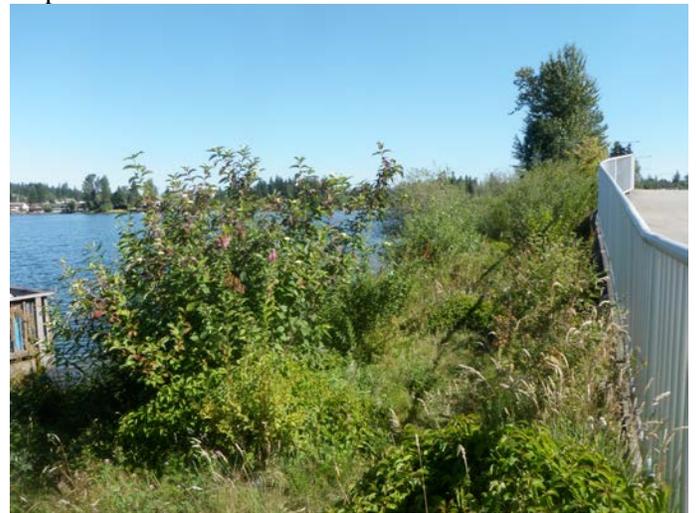
Shoreline: 80 percent cover (some areas have higher cover and others have less cover, but overall shoreline plantings provide 80 percent cover) (Photo 1).

Photo 1 – Woody cover at the shoreline

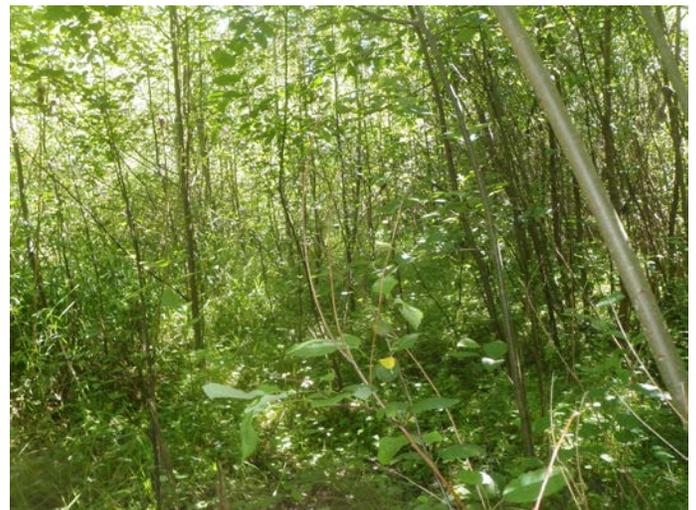
Wetland: 95 percent cover with three layers to the canopy (tree layer, shrub layer, herbaceous understory) (Photo 2).

Photo 2 – Woody cover in the wetland.
