*SR 24, I-82 TO KEYS ROAD PROJECT*

**UNDERWATER SOUND LEVELS  
ASSOCIATED WITH PILE DRIVING ON  
THE SR 24, I-82 TO KEYS ROAD  
PROJECT – YAKIMA RIVER**

*Prepared by:  
Jim Laughlin  
Washington State Department of Transportation  
Office of Air Quality and Noise  
15700 Dayton Avenue North, P.O. Box 330310  
Seattle, WA 98133-9710*

**July 2005**

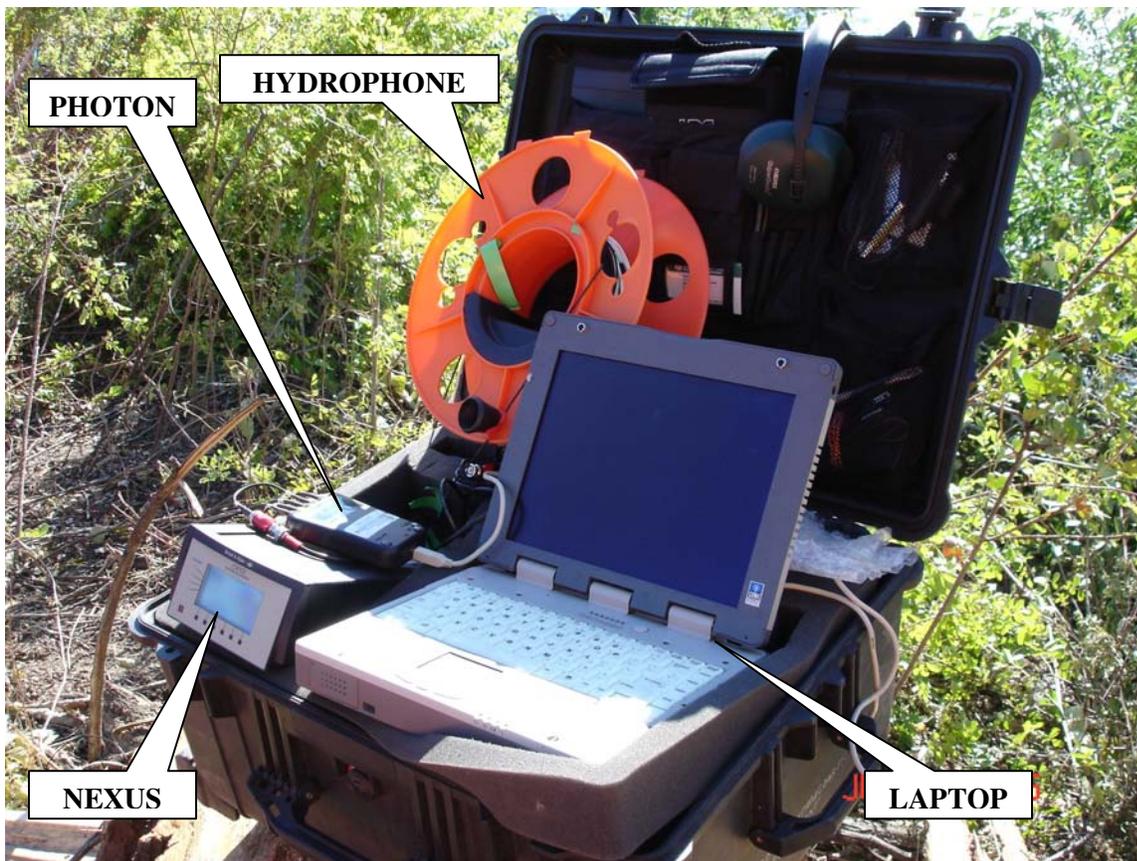
**Figure 4: Underwater Sound Level Measurement Equipment**

Underwater sound levels were measured using one Reson TC 4013 hydrophone. One hydrophone was positioned approximately at mid-water level. The hydrophone was located at a distance of 33 feet from the pile and downstream of the pile being monitored. The measurement system includes a Brüel and Kjær Nexus type 2692 4-channel signal conditioner, which kept the high underwater sound levels within the dynamic range of the signal analyzer (Figure 4). The output of the Nexus signal conditioner is received by a Dactron Photon 4-channel signal spectrum analyzer that is attached to an Itronix GoBook II laptop computer. The waveform of the pile strikes along with the number of strikes, overpressure minimum and maximum, absolute peak values, and RMS sound levels, integrated over 90% of the duration of the pulse, were captured and stored on the laptop hard drive for subsequent signal analysis. The system and software calibration is checked annually against a NIST traceable standard. The operation of the hydrophone was checked in the field using a GRAS type 42AC high-level pistonphone with a hydrophone adaptor. The pistonphone signal was 146 dB re: 1  $\mu$ Pa. The pistonphone signal levels produced by the pistonphone and measured by the measurement system were within 1 dB and the operation of the system was judged to be acceptable over the study period. A photograph of the system and its components are shown in Figure 4.

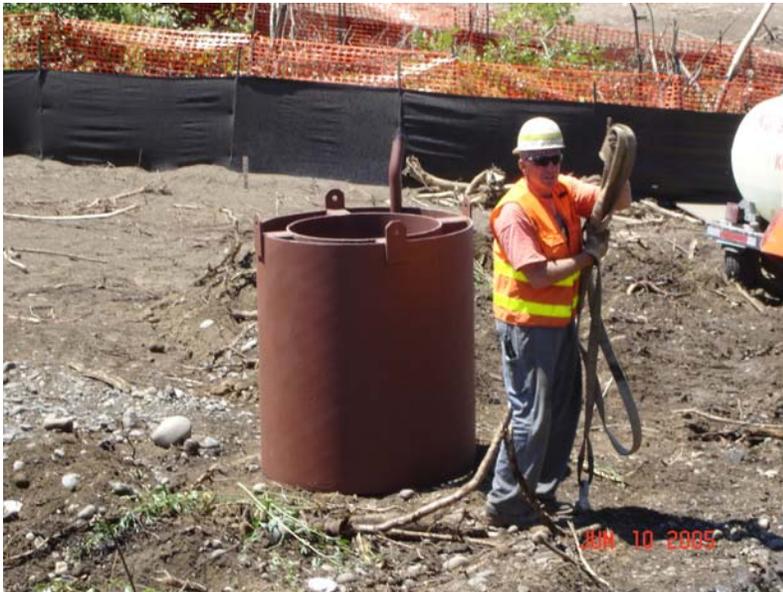
**Figure 7: Confined bubble curtain for use in shallow waters with swift currents.**

The first of two piles driven at a depth of one foot was Pile 2, driven with a diesel hammer. The confined bubble curtain (Figure 7) was deployed for this pile but the bubbles were not turned on because the contractor wanted to see if they could drive the pile and stay under the thresholds set by NMFS. The contractor would start the impact hammer, and as the blows approached and eventually exceeded set thresholds, the contractor was instructed to temporarily cease pile-driving operations. This start-stop process continued until the pile was almost completely driven to depth.

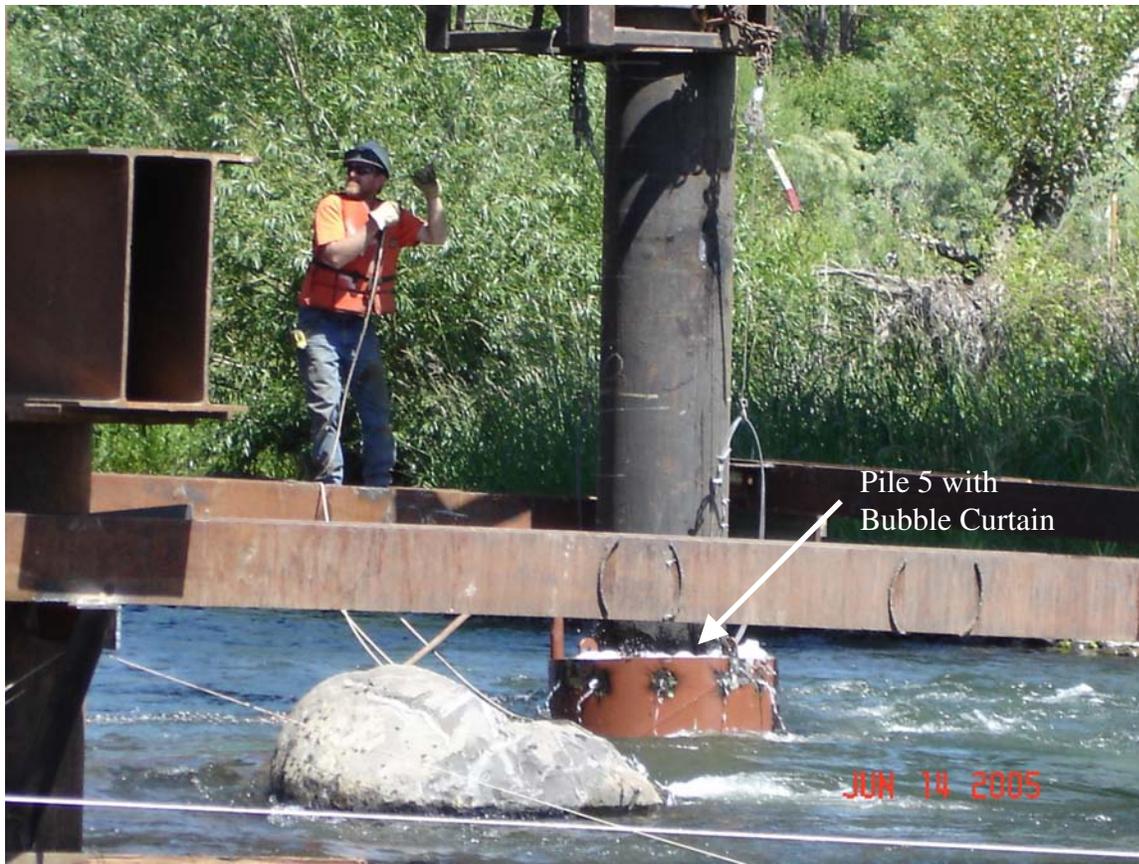
**Figure 10: Pile 5 with Bubble Curtain in Operation.**

The second of two piles driven at this depth was Pile 5 driven with a diesel hammer in a water depth of two feet. A large grab was used to pluck the larger boulders ranging from four to five feet across from the site where Pile 5 was to be driven. This would also have the additional benefit of allowing the casing on the bubble curtain to seat properly. The confined bubble curtain was deployed for this pile and bubbles were on during the entire driving event (Figure 10).
