RE: I-5 SR 432 Talley Way Interchange (Carrolls Creek) Wetland Mitigation Site
USACE Nationwide Permit (23) NWS-2009-444

The Washington State Department of Transportation completed qualitative monitoring of the I-5 Carrolls Creek mitigation site on July 30, 2014, to address Year-3 (2015) performance standards. Monitoring activities included vegetation observations and photo documentation. This Year-2 report is being issued for compliance with the reporting requirements of the United States Army Corps of Engineers Permit Number NWS-2009-444.

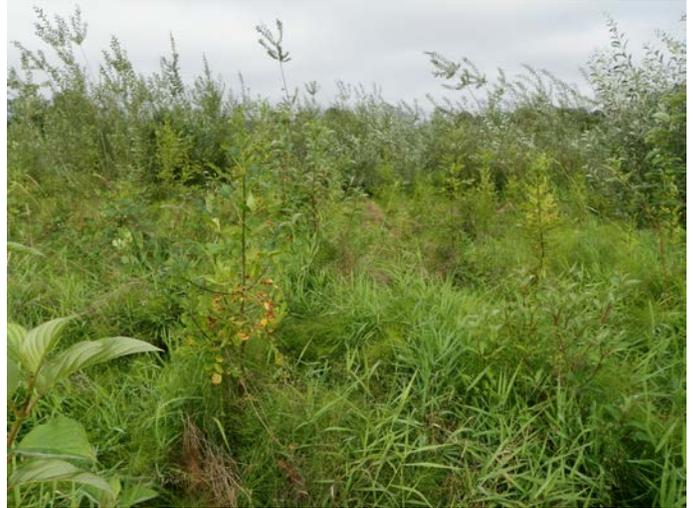
Photo 1 – Woody density in the forested wetland (July 2014)

The density of native shrubs in the forested wetland (Photo 1) is visually estimated to be less than 4,000 shrubs per acre. This attribute will be assessed with statistical sampling in 2015.

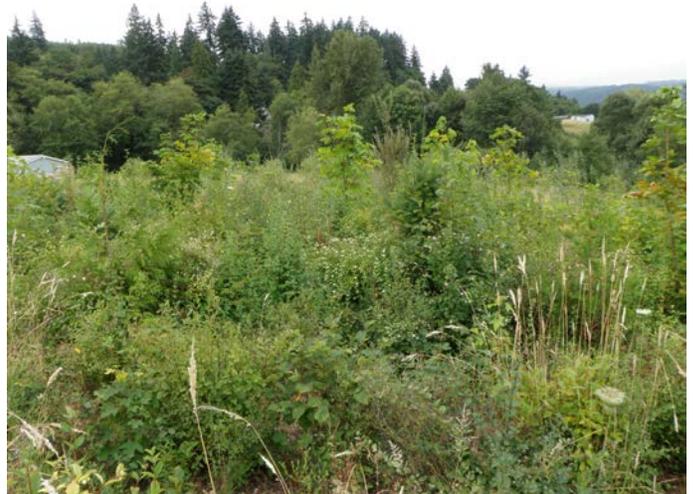
The density of native shrubs in the buffer (Photo 2) is visually estimated to be less than 4,000 shrubs per acre. This attribute will be assessed with statistical sampling in 2015.

Photo 2 – Woody density in the buffer (July 2014)
