**SR 502 NE 15th Ave to NE 102nd Ave
(Sunset Oaks) Mitigation Site**

USACE NWS-2009-1093

2014 MONITORING REPORT

Issued March 2015

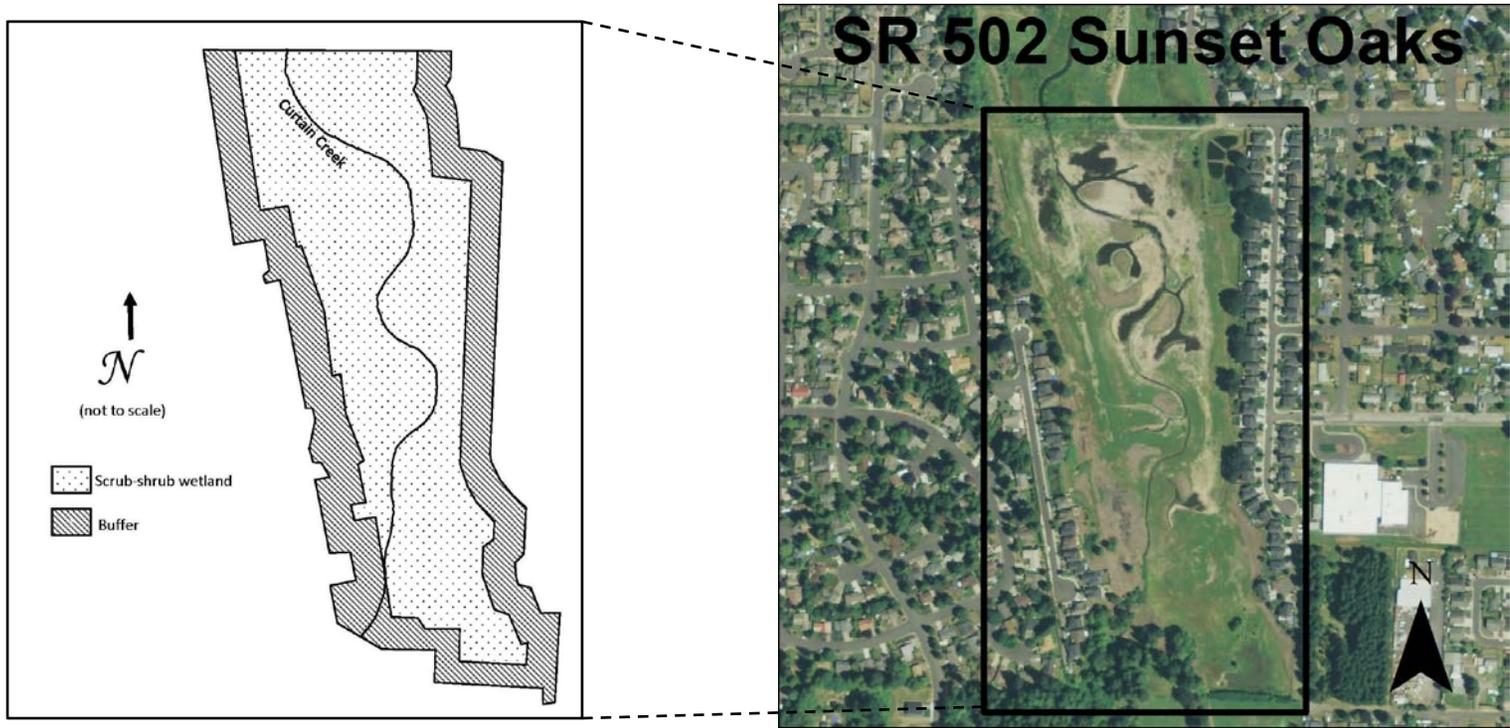
Figure 1 Site Sketch

The SR 502 Sunset Oaks Mitigation Site contains a mosaic of forested, scrub shrub, and emergent systems on either side of the realigned Curtain Creek. Upland and wet buffer areas surround the site to the east, west, and south. Appendix 2 includes site directions.

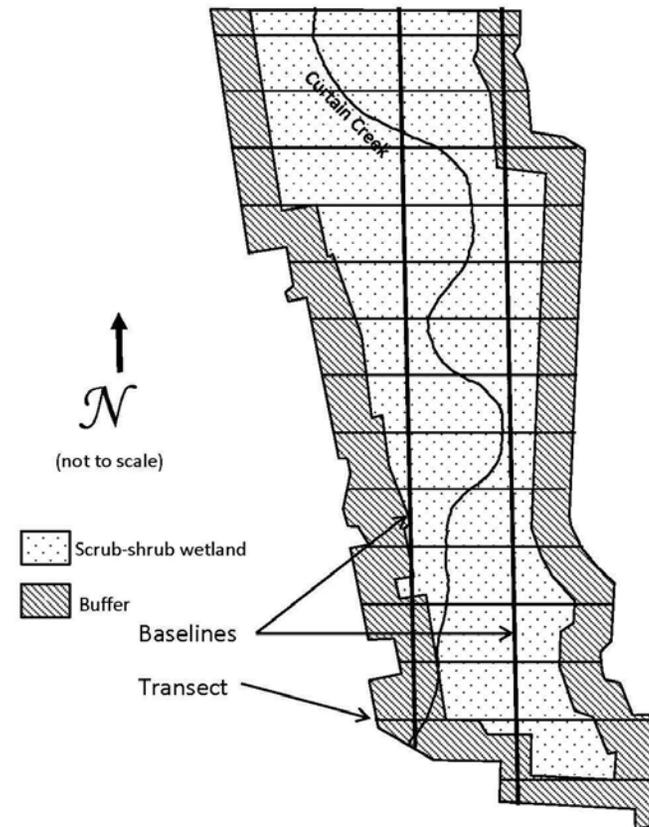
Figure 2 Site Sampling Design (2014)

To evaluate standards for vegetative cover, a baseline was established on the east and west side of Curtain Creek (Figure 2). Twenty-four sampling transects were randomly placed perpendicular to each baseline. The unequal-area belt transect method was used to estimate woody survival (Performance Standard 2). The presence of blackberry species, county listed Class-B weeds (Performance Standard 3), Class A Noxious Weeds, Japanese knotweed, purple loosestrife (Performance Standard 4), and reed canarygrass (Performance Standard 5) were estimated qualitatively with visual assessments.

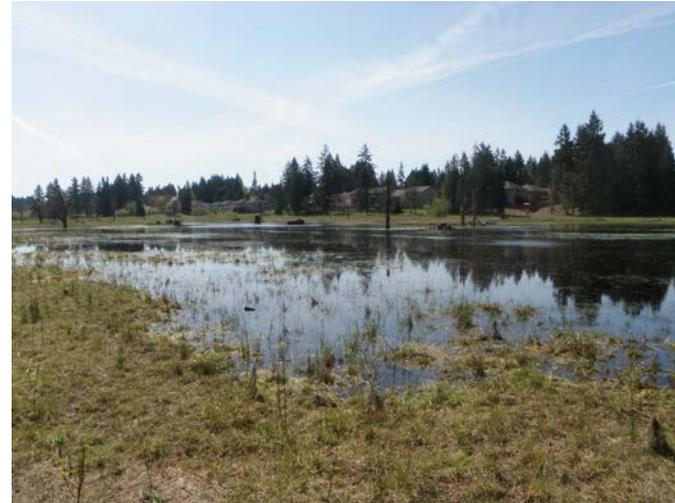
Photo 1 Shallow inundation in scrub-shrub wetland (April 2014)

Wetland hydrology was not consistently observed in all intended wetland areas in 2014, despite obvious surface water and saturation observed across much of the site on all three visits (Photo 1). This may be due to the fact that well installations occurred on each visit wells were monitored. It is likely that the water levels did not have time to equilibrate after installation when they were checked. See Table 2 Appendix 3 for hydrology monitoring results.

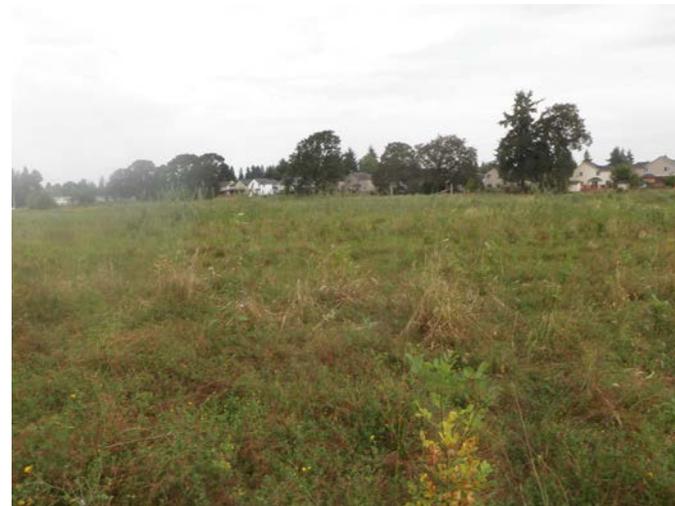
Photo 2 Woody plantings in the scrub-shrub wetland (August 2014)

Survival was assessed across the buffer areas and wetland areas separately. Survival across the wetland area is 92% (CI_{80%} = 88-95%) in the wetland (Photo 2). This survival estimate likely achieves the performance standard target. Most of the observed mortality was observed in the northeastern portion of the wetland that appears to be wetter than intended. Survival in the buffer areas is 97% (CI_{80%} = 96-98%) (Photo 3).
