SR 539 Potter Road Mitigation Site

Northwest Region

2014 MONITORING REPORT

**Washington State
Department of Transportation**

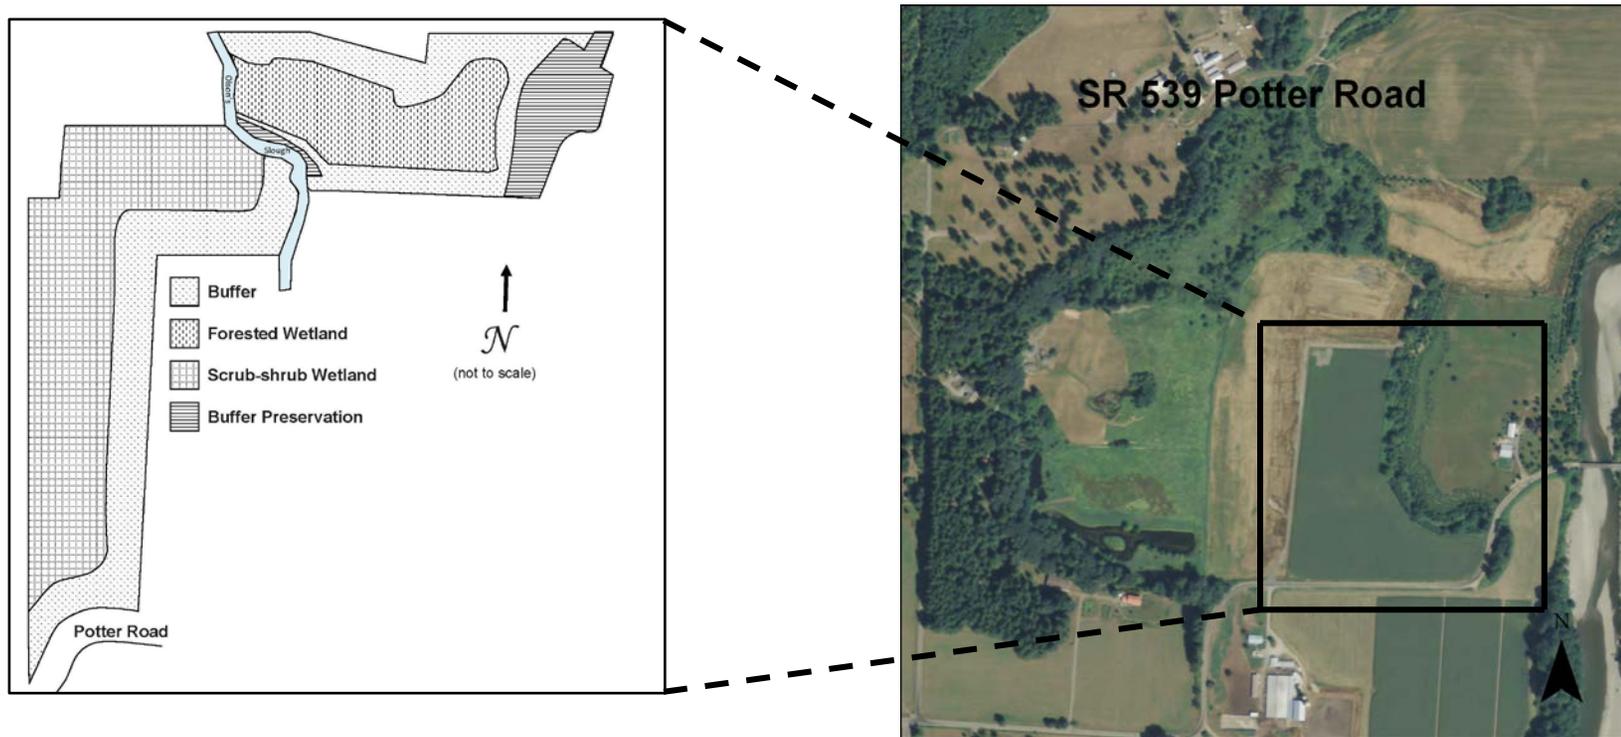
Figure 1 Site Sketch

The SR 539 Potter Road Mitigation Site consists of a scrub-shrub and forested wetland and upland buffer. The site is bisected by Olson's Slough, which drains into the South Fork of the Nooksack River. Appendix 2 includes site directions.

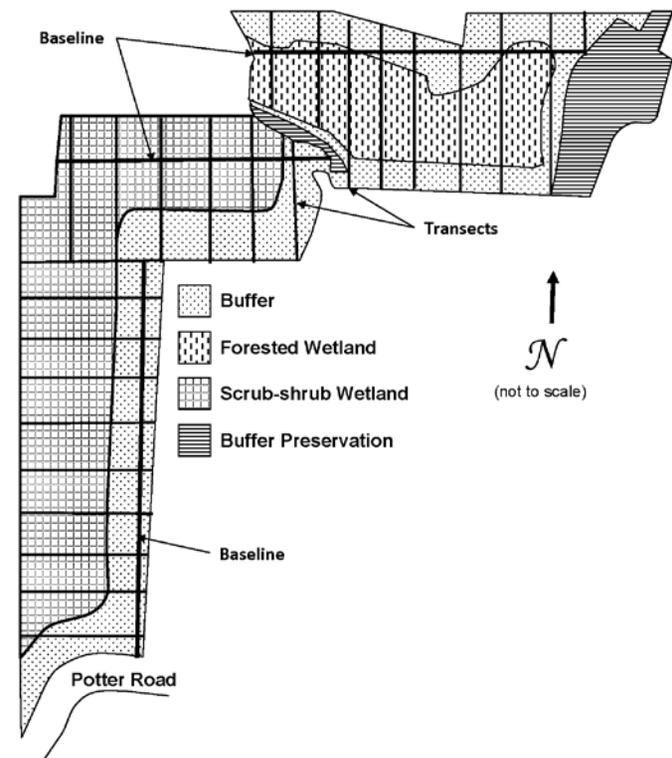
Figure 2 Site Sampling Design (2014)

sample unit had 40 points spaced 0.5 meters apart. Invasive cover in the buffer was visually estimated (Performance Standard 6).

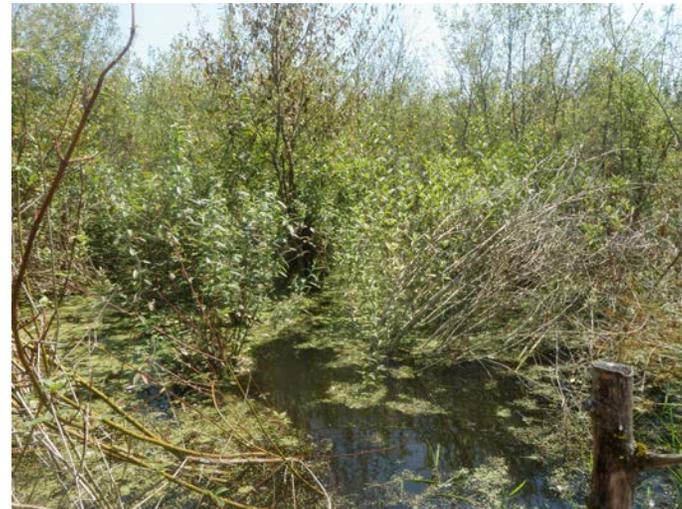
Photo 2
Cover in the wetland (July 2014)

Native cover of facultative and wetter woody species in the wetland is 63 percent ($CI_{80\%} = 56-71\%$) (Photo 2). This exceeds the performance standard target. Dominate species in the wetland include: black cottonwood (*Populus balsamifera*), Sitka willow (*Salix sitchensis*), Pacific willow (*Salix lasiandra*), twinberry honeysuckle (*Lonicera involucrata*), and black hawthorn (*Crataegus douglasii*). Redosier dogwood (*Cornus alba*) were also observed during monitoring activities.

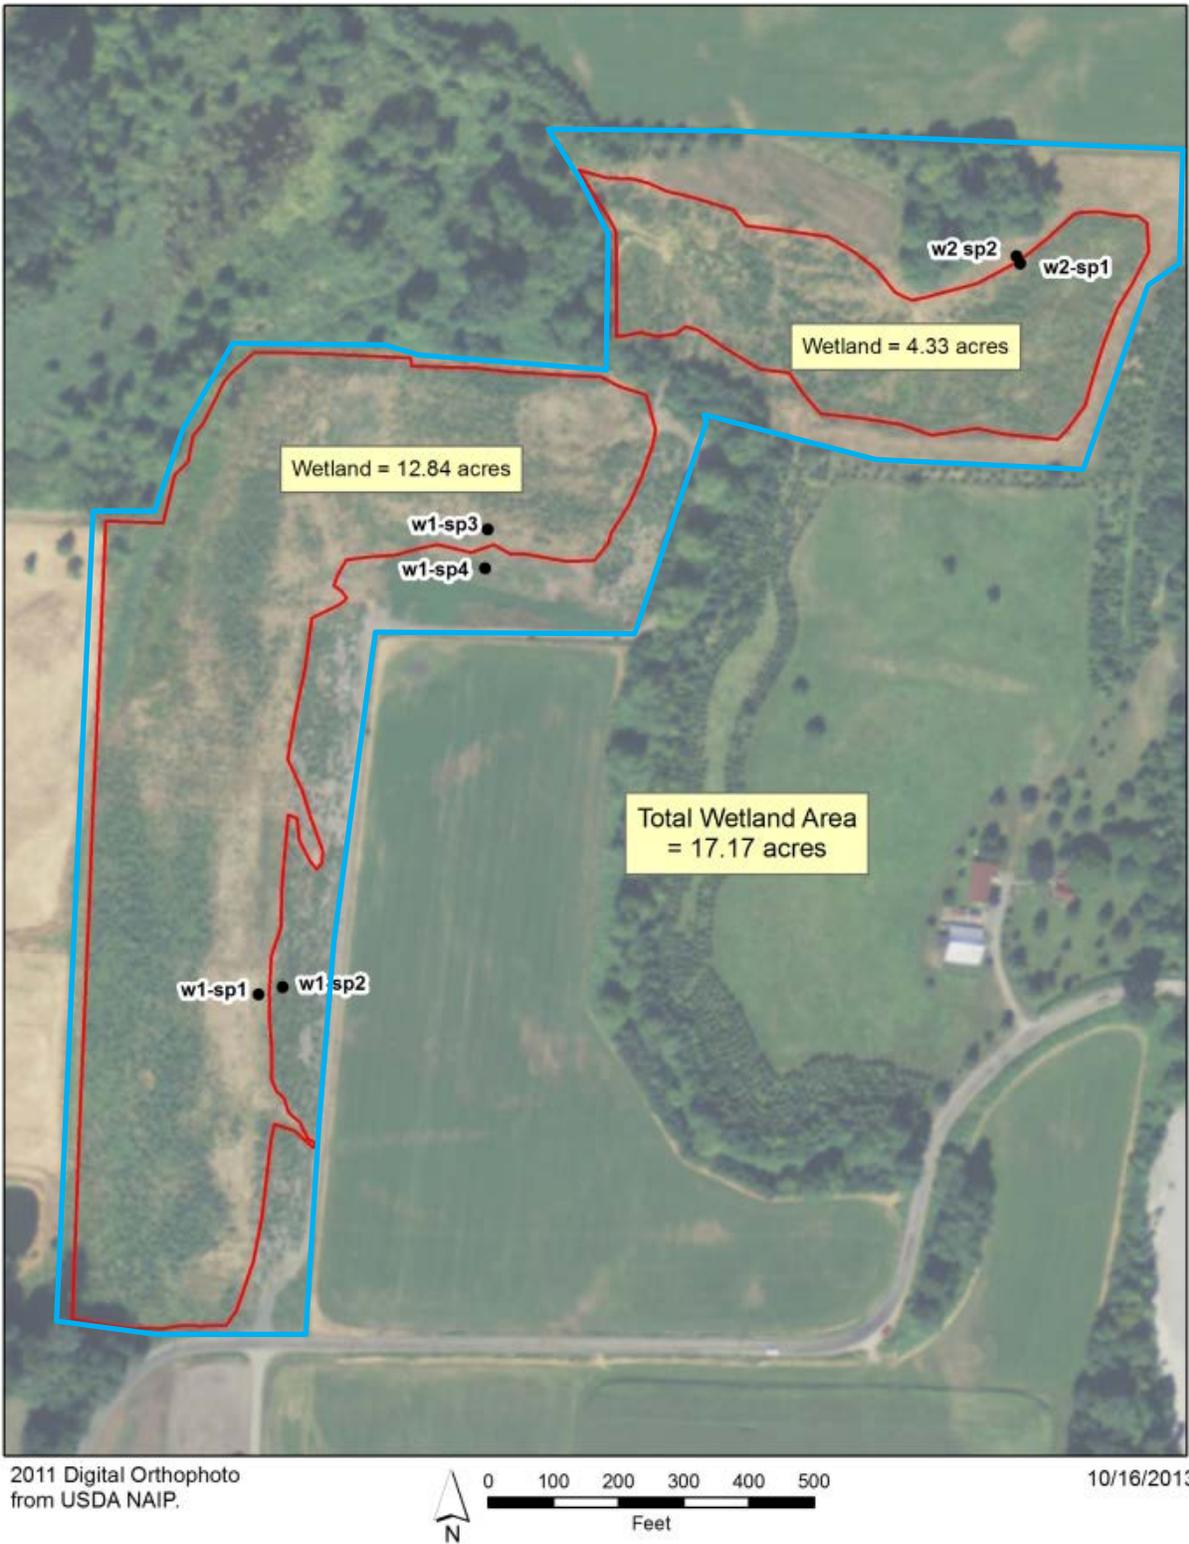
Figure 2. Study area in blue, wetland boundary in red, and sampling point locations in black.

The delineation determined 17.17 acres of wetland were present within the SR 539 Potter Road mitigation site. Field work for Wetland 1 (W1) occurred on May 7, 2013. Wetland 2 (W2) was delineated on October 14, 2013. Delineation data were collected at six sampling points and recorded on wetland determination data forms (Appendix A). Paired wetland and upland sample points were used to define the wetland edge. Data recorded on wetland determination data forms characterize typical wetland and upland conditions observed on site. Vegetation, soils, and hydrology were examined in many additional sampling locations to determine the wetland boundary.

Beaver activity, resulting in permanent, deep inundation was observed in the central portion of the site in July 2014. Because beavers add complexity and dynamic elements to a wetland system that may be ephemeral or longer lasting, site conditions including wetland boundary may change over time.

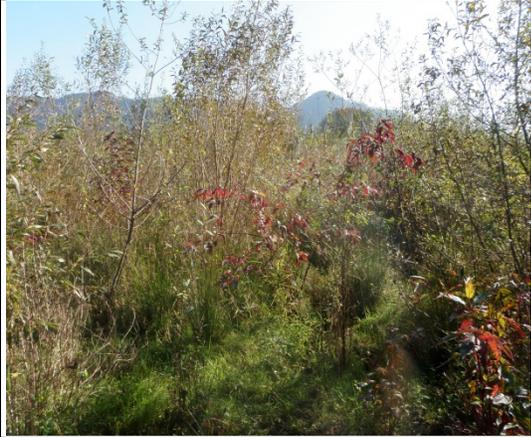
SR 539 Potter Road Mitigation Site – Wetland Delineation Summary

Total Delineated Wetland Area		17.17 acres

Wetland Determination Data Form(s)	Appendix A; Sampling Point W1-SP1, W1-SP3, W2-SP1	
	Upland Determination Data Form(s)	Appendix A; Sampling Point W1-SP2, W1-SP4, W2-SP2	
	Delineator(s)	Doug Littauer Sean Patrick	
	Delineation Dates	W1 on May 7, 2013 W2 on October 14, 2013	
Vegetation	<p>Trees – none</p> <p>Shrubs – Sitka willow (<i>Salix sitchensis</i>), Pacific willow (<i>Salix lasiandra</i>), black cottonwood (<i>Populus balsamifera</i>), Pacific crabapple (<i>Malus fusca</i>), Nootka rose (<i>Rosa nutkana</i>), snowberry (<i>Symphoricarpos albus</i>), twinberry honeysuckle (<i>Lonicera involucrata</i>), redosier dogwood (<i>Cornus alba</i>), and black hawthorn (<i>Crataegus douglasii</i>)</p> <p>Herbs – water foxtail (<i>Alopecurus geniculatus</i>), reed canarygrass (<i>Phalaris arundinacea</i>), creeping buttercup (<i>Ranunculus repens</i>), soft rush (<i>Juncus effusus</i>), sawbeak sedge (<i>Carex stipata</i>), American speedwell (<i>Veronica americana</i>), and fringed willowherb (<i>Epilobium ciliatum</i>)</p>

Soils	Soils examined to a depth of 18 inches exhibited hydric characteristics. Matrix colors of 10YR 2/1, 10YR 3/1, 2.5Y 4/1, 2.5Y 4/2, and 2.5Y 5/1 were observed. Redoximorphic concentrations and depletions were observed throughout the soil profile. Indicator Depleted Matrix (F3) met.		
Hydrology	A high groundwater table associated with the South Fork Nooksack River provides the primary hydrologic inputs on site. Riverine influences come to W1 as sheet flow along the western edge of the site and to W2 through a semi-constricted inlet on the west side of the wetland. Gently sloping topography carries surface and subsurface flows from agricultural fields to the east into W1. W2 had depressional areas. Beaver activity has increased surface water levels and duration in the central and northern portions of the site in W1 following the 2013 delineation. Water in the observation pits ranged 3 to 10 inches below the surface. Shallow inundation was observed in some areas of W1. Surface water to greater than two feet deep was observed in some areas of W2. Oxidized rhizospheres and water-stained leaves were also observed in some locations.
