MT. BAKER HIGHWAY SCENIC BYWAY MANAGEMENT PLAN

NATURAL FORCES THAT INFLUENCE THE CORRIDOR

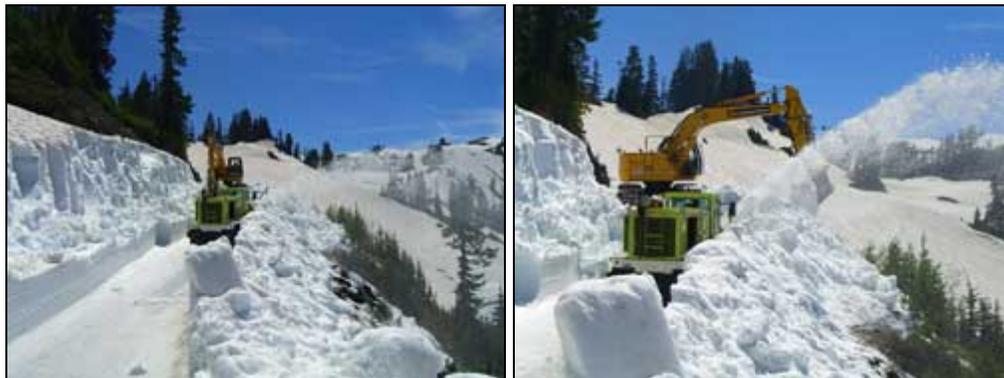
2008 snow clearing to Artist Point

Glaciers/snowfall- Glaciers are present in this area, but have not posed a threat to the roadway beyond the normal glacial melt associated with spring. Mount Baker also has significant seasonal snowfall. In 1999, it set the record of the snowiest places in the world, as well as setting the world record for snowfall in a single season. (1,140 inches/95 feet). Every year provides snow clearing challenges that are necessary to open the access to Artist Point.

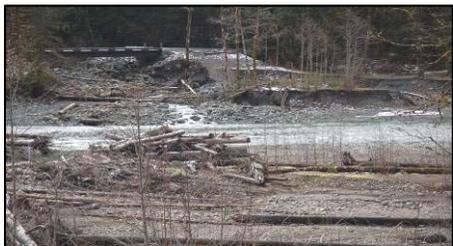
Nooksack River eroding steep bank

Bank next to Nooksack River

SR 542 is located immediately adjacent to Nooksack River. This system frequently erodes portions of the road during high flow events. Emergency repairs have been necessary, require immediate action and are often a temporary remedy for problematic site conditions. The WSDOT and the USFS have coordinated closely when emergency actions are needed to keep the roadway functioning and safe. Emergency repairs (usually the addition of riprap) often have environmental impacts within the stream channel that are not conducive to the long-term resource protection of the river and its floodplain. Chronic Environmental Deficiency retrofit projects are being undertaken in some of these areas to provide environmental enhancements and to address all the necessary resource protection needs within the project areas.

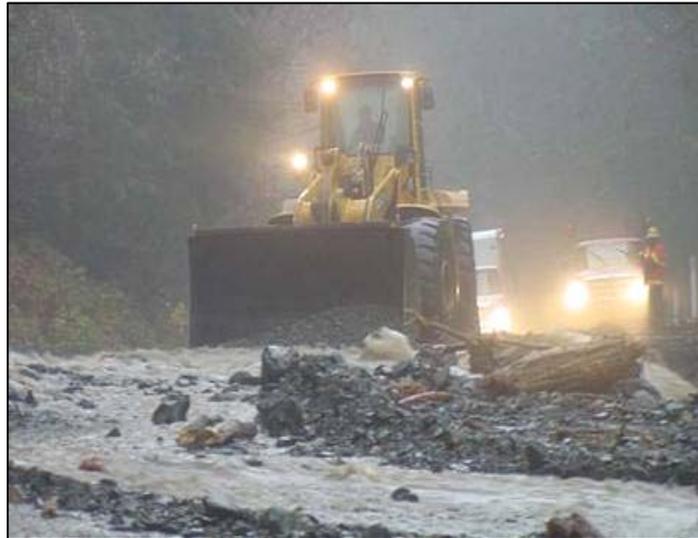
Flood water across SR 542 in Fall 2006

High flow events on the Nooksack challenge the roadway system and require diligent maintenance to keep SR 542 from washing out. The Nooksack River along with its many tributaries requires vigilant road work to keep the system functioning safely. These systems are adjacent to the roadway or cross the roadway, and sometimes require annual debris removal to keep the water in the channel and off the road. This process includes obtaining permits from WDFW including an on-site review. Activities occur in the mid summer of each year to comply with appropriate aquatic timing restrictions. This time was chosen because flows are low and aquatic and wildlife resources are least impacted.
