**SR 539 Widening Project: Horton Road to Ten Mile Road  
(MP 1.64 to MP 6.26) (Strand) Mitigation Site  
WIN #A53902D**

**USACE 200500927**

**2014 MONITORING REPORT**

**Washington State  
Department of Transportation**

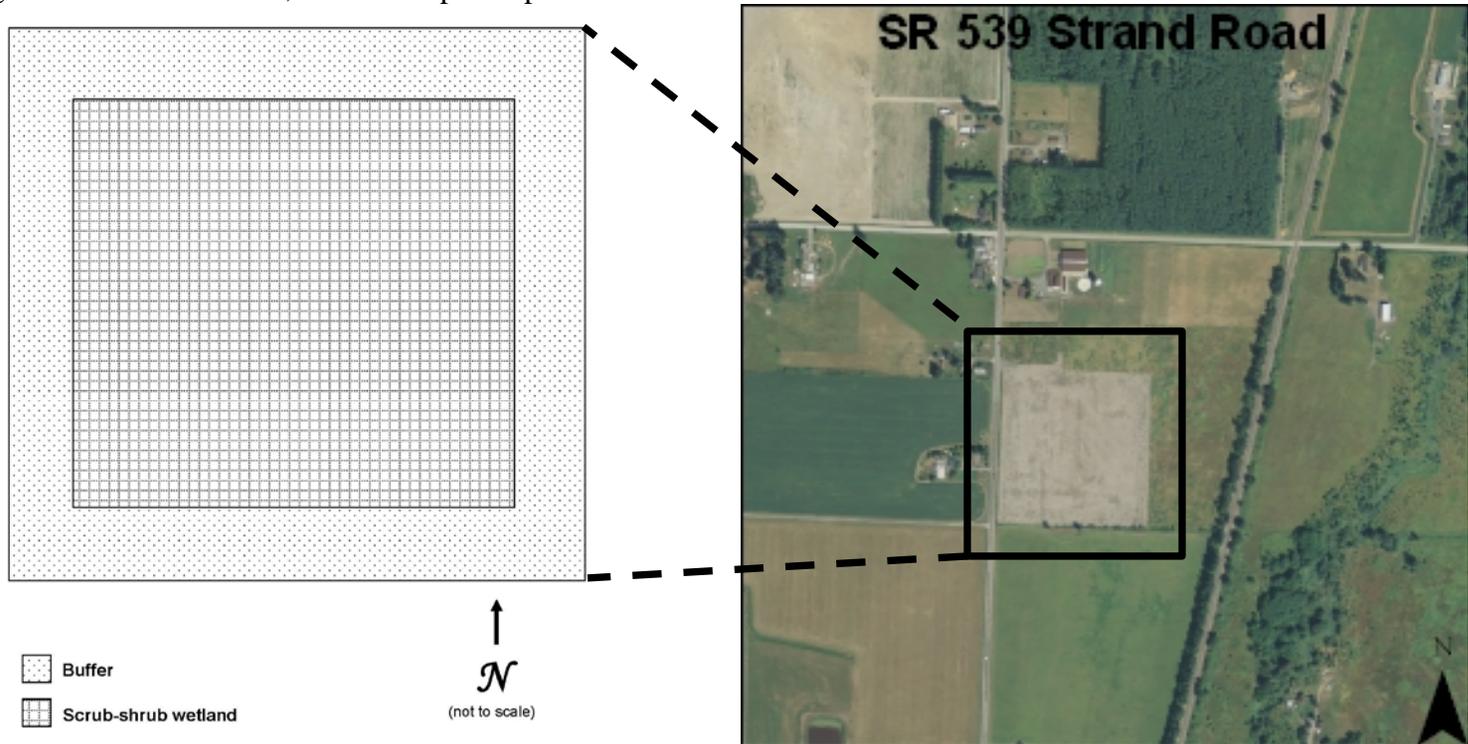
**Figure 1 Site Sketch**

This 10.54 acre mitigation site (Figure 1) provides 6.26 acres of wetland enhancement and 4.37 acres of wetland buffer enhancement. This site was created to partially compensate for the loss of 5.97 acres of wetlands due to road improvements along SR 539. The enhanced wetland area is anticipated to provide flood flow alteration, sediment removal, nutrient and toxicant removal, general wildlife habitat, and native plant species richness.

The SR 539 Strand Road Mitigation Site consists primarily of dense scrub-shrub with an underlying herbaceous layer of vegetation surrounded by an 80-foot enhanced buffer. Appendix 2 includes site directions.

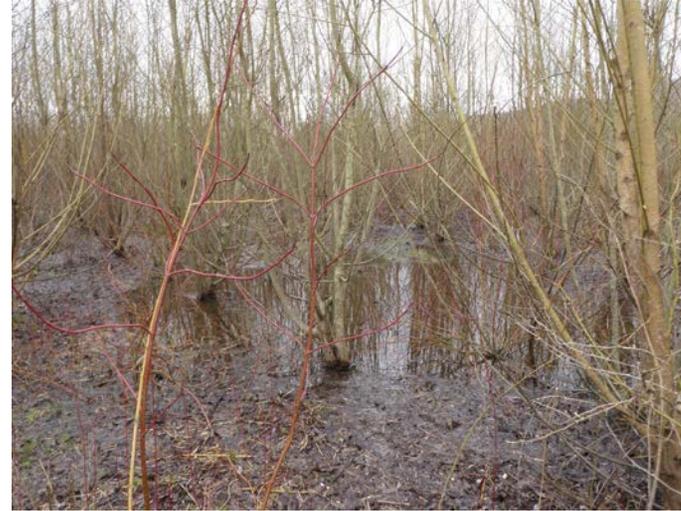
Water was present within the upper 12 inches of the soil across the site during each of the three site visits (Photo 1). Wetland hydrology was documented in all four ground monitoring wells on each of the three spring hydrology visits. See Appendix 3 Table 3 for complete results.

**Photo 1**  
**Surface saturation and inundation in the wetland**  
**(March 2014)**

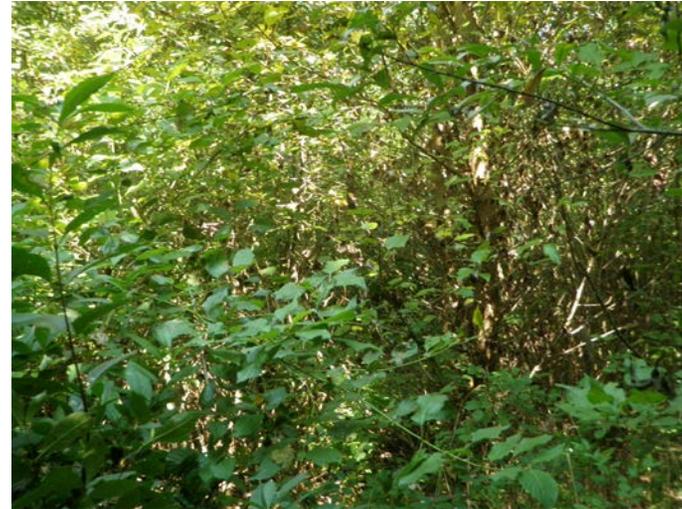
Native woody coverage is 90 percent with two layers of well-developed canopy (Photo 2). The overstory provides approximately 90 percent cover by five meter tall willows (*Salix* spp.). An understory of native shrubs provides approximately 30 percent cover. Understory dominant plants include: black hawthorn (*Crataegus douglasii*), twinberry honeysuckle (*Lonicera involucrata*), Nootka rose (*Rosa nutkana*).

**Photo 2**  
**Woody cover in the wetland (August 2014)**

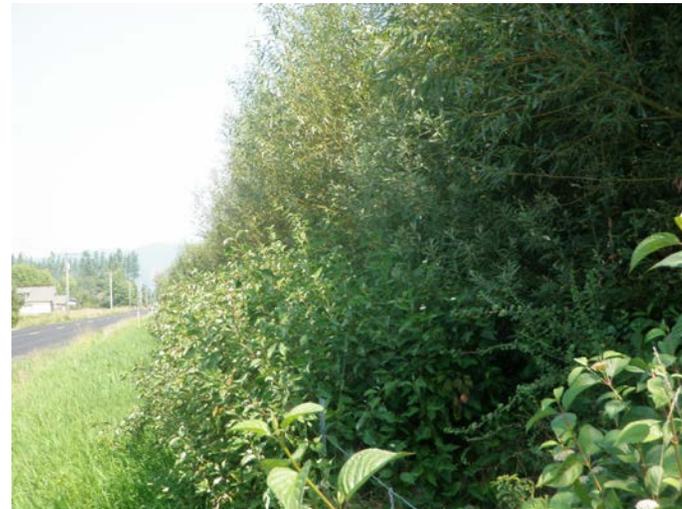
The plant community in the buffer and wetland is virtually undistinguishable. Cover in the buffer is 90 percent and has similar native species and canopy structure developing as the wetland discussed above (Photo 3).

**Photo 3**  
**Woody cover in the buffer (August 2014)**
