SR 20 Gages Slough Mitigation Site

SR 20 Fredonia to I-5 (WIN: A02039B) - IP NWS-2005-1406
Mt. Vernon Rail Siding Upgrade Project - NWP (23) NWS-2007-236

2014 MONITORING REPORT

Issued March 2015

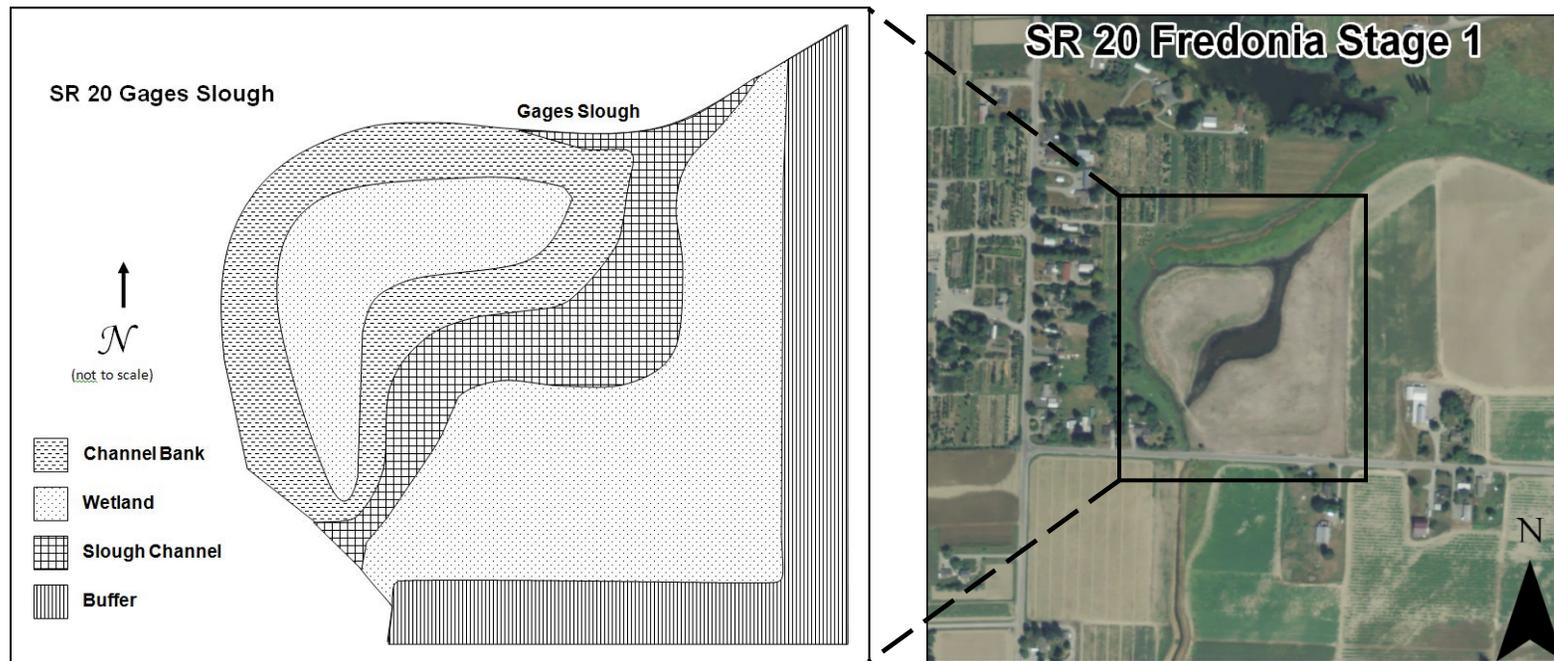
Figure 1 Site Sketch

The SR 20 Gages Slough Mitigation Site contains an aquatic bed channel edged by an emergent community, surrounded by scrub-shrub and forested wetland communities, and with upland buffer bordering the south and east sides. Appendix 2 includes site directions.

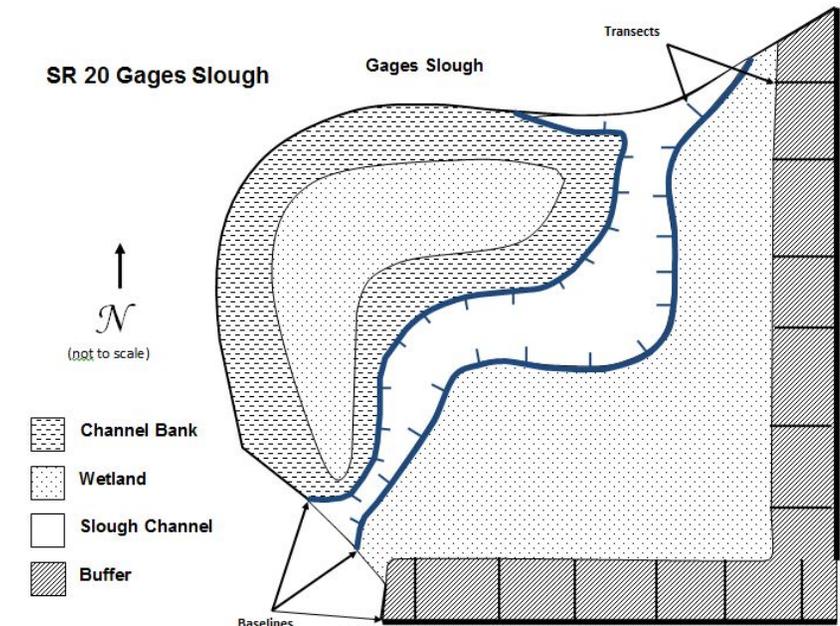
Figure 2 Site Sampling Design (2014)

To assess vegetation standards, two separate baselines were established, each in two segments. Temporary sampling transects were placed perpendicular to each baseline using a systematic random sampling method (Figure 2). In the buffer, a 448-meter baseline was established in two segments along the southern and eastern borders of the site. The line-intercept method was used to estimate native woody cover in this zone (Performance Standards 6 and 8). Twenty-three 10-meter-long line-segment sample units were randomly positioned along the transects. In the emergent wetland, a 546-meter baseline was established in two segments following the curve of the banks. The point-line method was used to estimate the cover of native facultative or wetter herbaceous vegetation in this zone (Performance Standard 4). Twenty-seven four-meter-long sample units (20 points each) were randomly positioned along the transects.

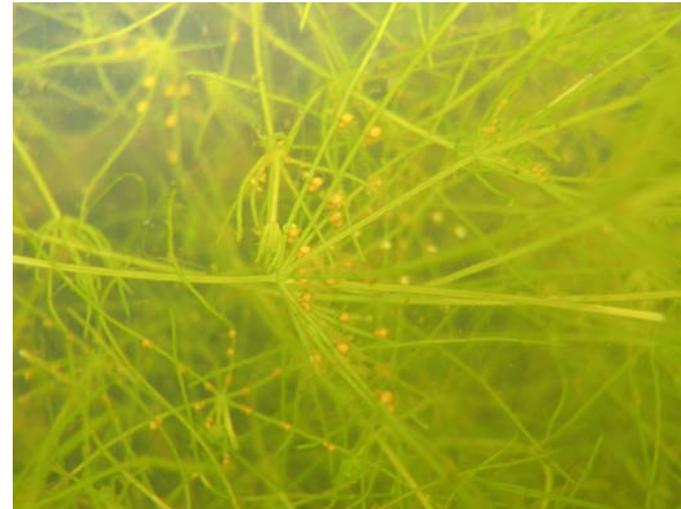
The aquatic bed community has developed at a much slower pace than the rest of the site. The dominant plant species in this community is Rocky Mountain pond-lily (*Nuphar polysepala*). Although the cover of this species has clearly increased over the last several years, from almost nothing in 2010 to roughly three percent in 2014, its spread has been slow and is so far limited to the shallowest portions of this area. The dominant organism in this community is a submersed plant-like macroalga called muskgrass (*Chara sp.*, see Photo 1) which provides about 75 percent cover. Since this species is technically not a plant, it was not included in cover estimates for this zone in 2014. The cover of these algae may have been mixed up with submersed aquatic plant species in this community in previous cover estimates, however, confusing the documentation of plant community development. It is also possible that these algae have displaced some of the cover of submersed aquatic plant species in this community, such as coon's-tail (*Ceratophyllum demersum*).

Photo 1
Muskgrass (*Chara sp.*) in the aquatic bed community
(August 2014)

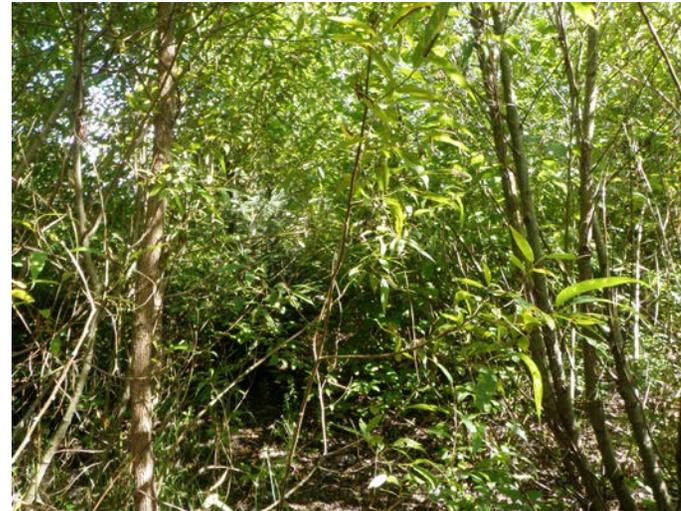
Based on monitoring results in 2012 and 2013, a request to discontinue quantitative sampling for wetland woody cover was sent to and accepted by the USACE and the Department of Ecology in the spring of 2014. The cover of native facultative or wetter woody species in the forested and scrub-shrub wetland communities (Photo 2) continues to exceed the final-year performance standard and was visually estimated at 95 percent in 2014.

Photo 2
Woody cover in the scrub-shrub wetland (August 2014)

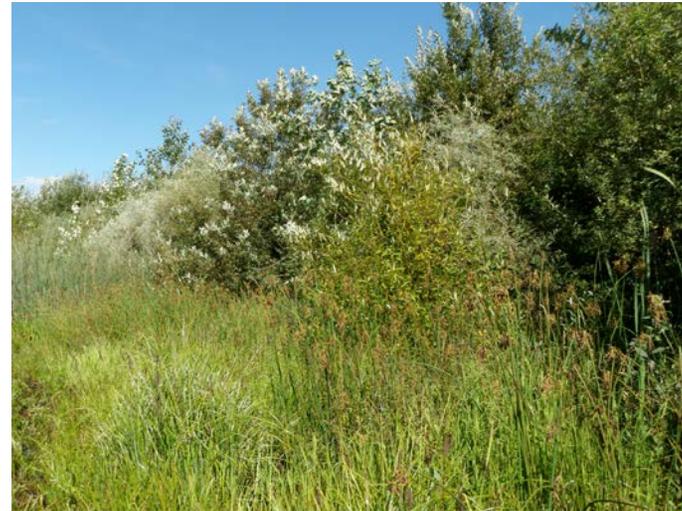
The cover of native facultative or wetter herbaceous vegetation in the emergent community (Photo 3) is estimated at 79% (CI_{80%} = 75-82%). This exceeds the current-year performance standard, and essentially equals the final-year performance standard of 80 percent. The dominant species in this zone are swamp smartweed (*Persicaria hydropiperoides*), soft-stem bulrush (*Schoenoplectus tabernaemontani*), rice cutgrass (*Leersia oryzoides*), and broadleaf cattail (*Typha latifolia*).

**Photo 3
Herbaceous cover in the emergent wetland
(August 2014)**

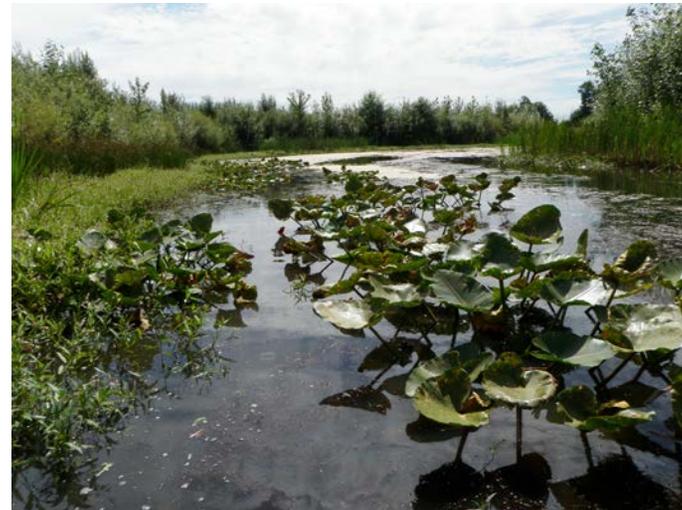
The cover of native facultative or wetter herbaceous vegetation in the aquatic bed community (Photo 4) was visually estimated at five percent. This cover consists primarily of Rocky Mountain pond-lily (*Nuphar polysepala*), along with some coon's-tail (*Ceratophyllum demersum*), floating-leaved pondweed (*Potamogeton natans*), and common duckweed (*Lemna minor*). In addition, there is a submersed plant-like macroalga called muskgrass (*Chara sp.*, see Photo 1) that provides about 75 percent cover in this area. Since this species is technically not a plant, it was not included in the overall cover estimate (see additional comments in the “How is the site developing?” section above).

**Photo 4
Herbaceous cover in the aquatic bed community
(August 2014)**

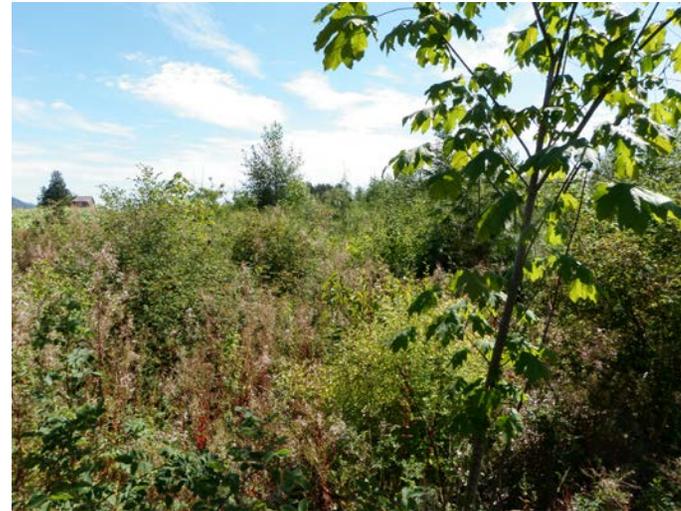
Photo 5
Woody cover in the buffer (August 2014)

The cover of native woody species in the buffer (Photo 5) is estimated at 73% ($CI_{80\%} = 68-79\%$). The dominant species in this zone are Nootka rose (*Rosa nutkana*), snowberry (*Symphoricarpos albus*), and beaked hazelnut (*Corylus cornuta*). The cover is denser in the eastern portion of the buffer than in the southern portion, presumably due to fertilizer-laden runoff from the adjacent farm.

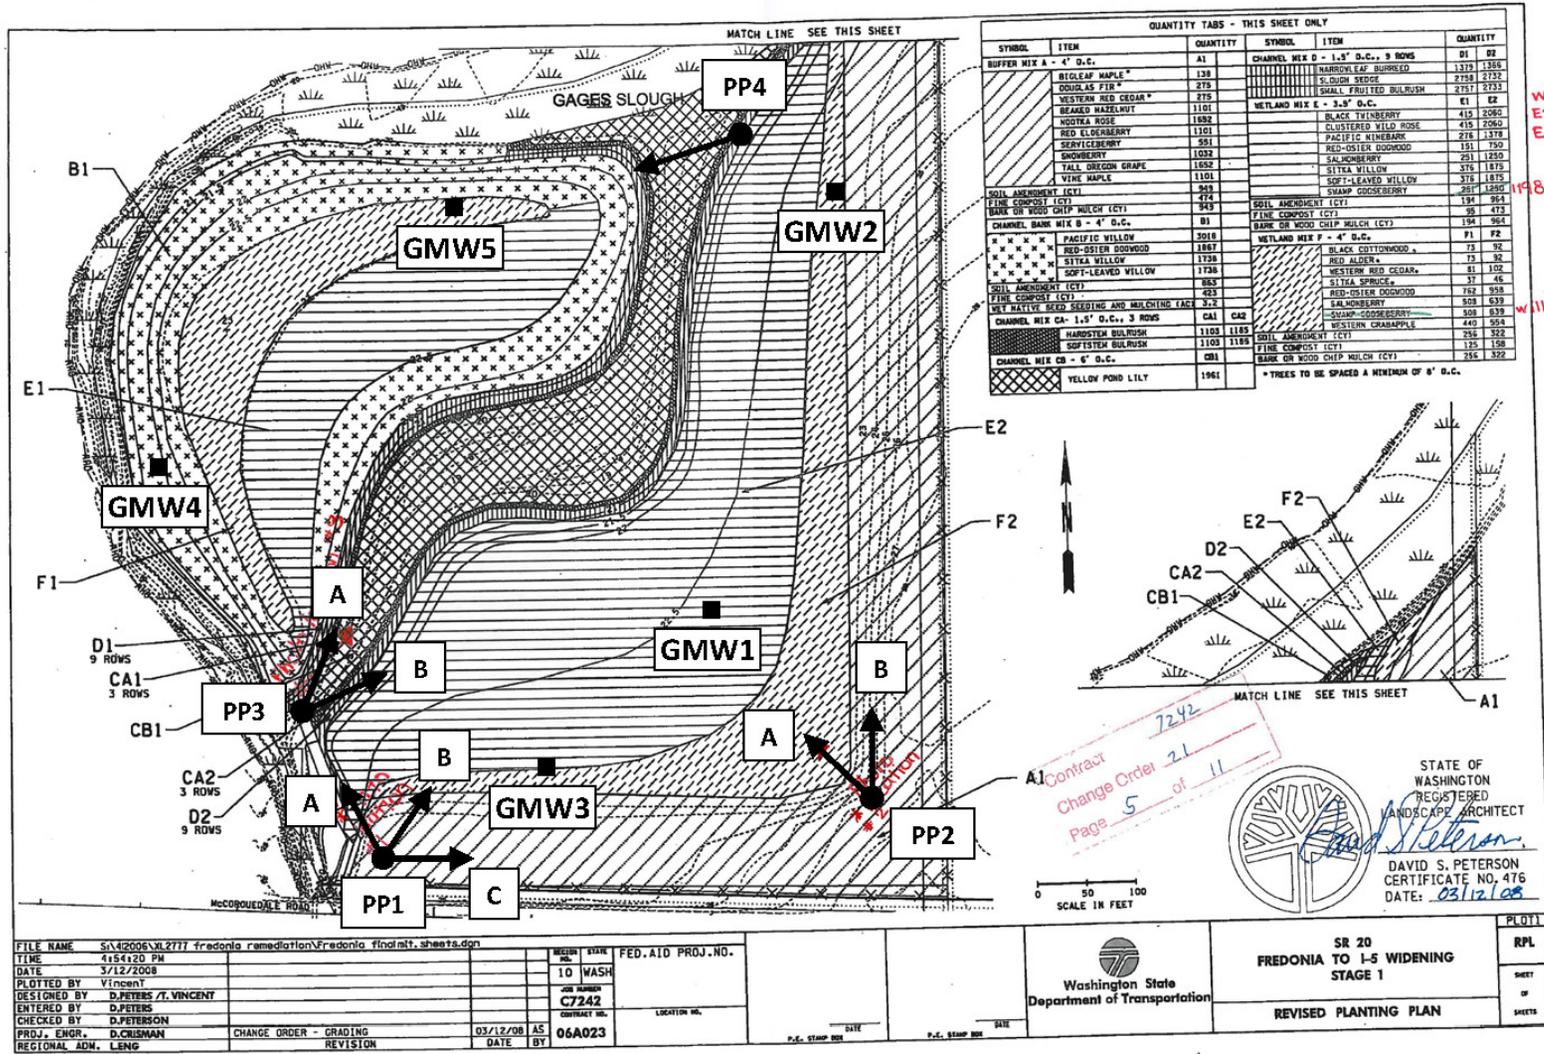
Appendix 1 – As-built Planting Plan with Photo Point and Groundwater Monitoring Well Locations

(from WSDOT 2008)

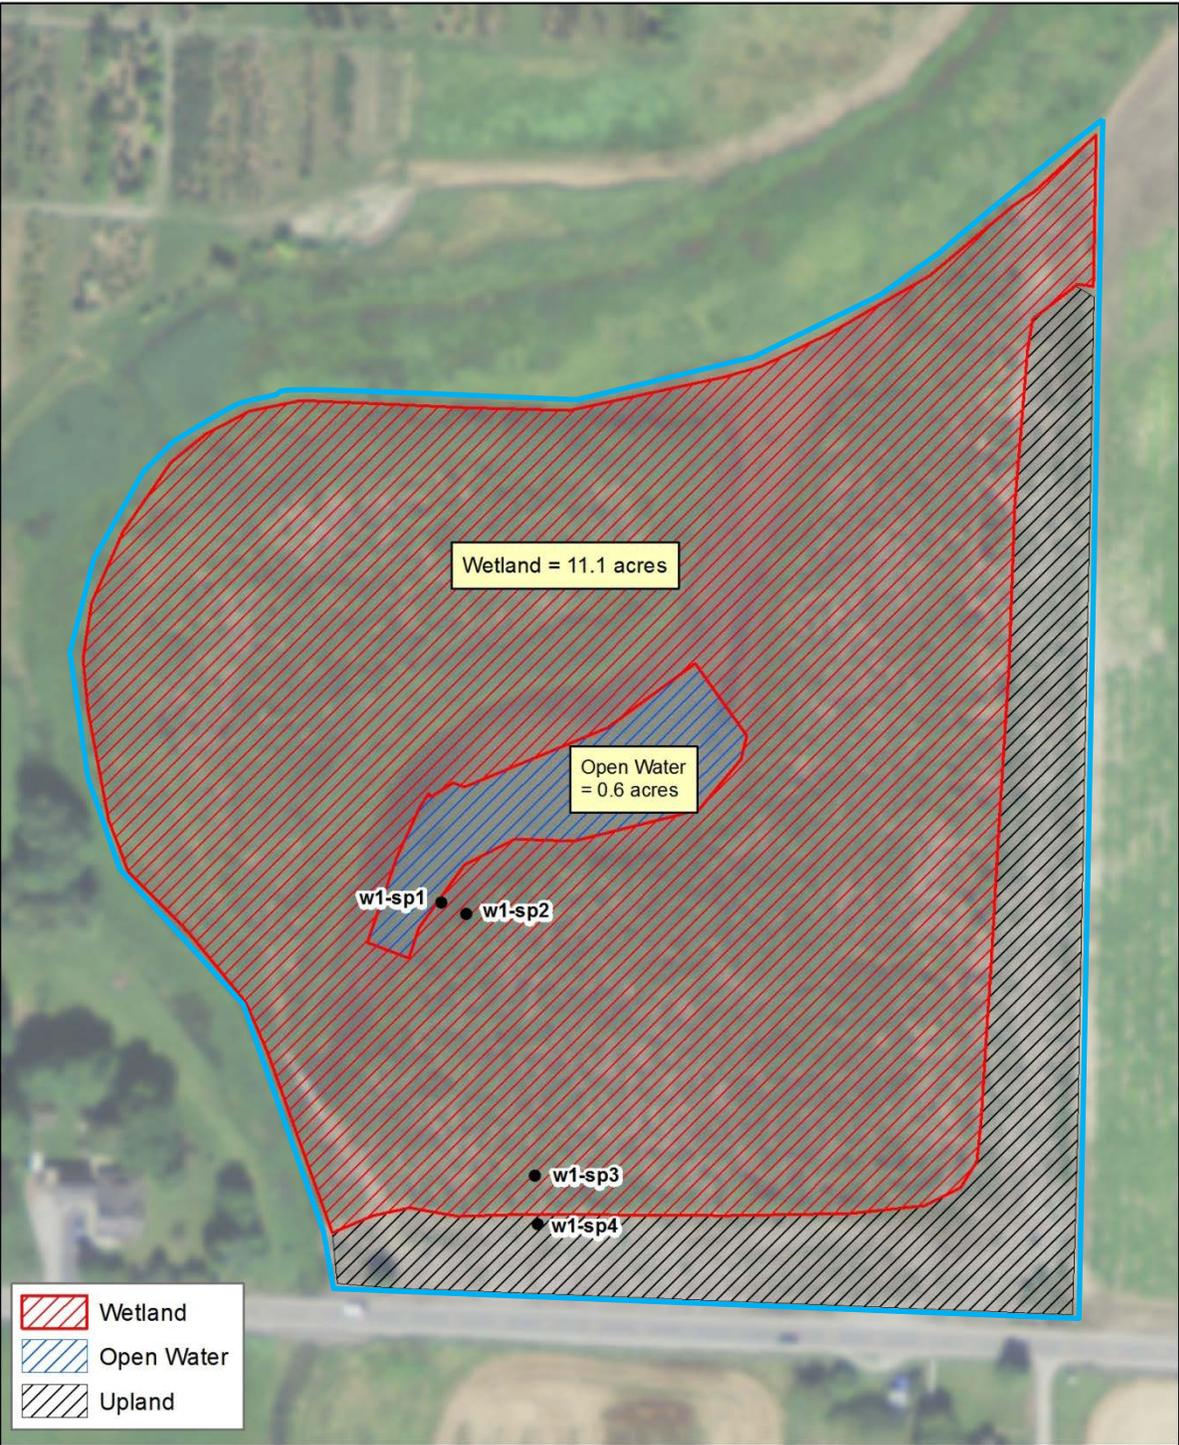
Delineation data were collected at four sampling points and recorded on wetland determination data forms (Appendix A). Paired wetland and upland sample points were used to define the wetland edge. Additional wetland sample points characterize various wetland vegetation communities. Data recorded on wetland determination data forms characterize typical wetland and upland conditions observed on site. Vegetation, soils, and hydrology were examined in many additional sampling locations to determine the wetland boundary. The delineation determined 11.7 acres of wetland were present within the SR 20 Gages Slough mitigation site, with 11.1 acres PEM /PSS wetland, and 0.6 acre of PAB/POW wetland.

Figure 2. Study area in blue, wetland boundary in red, and sampling point locations in black.

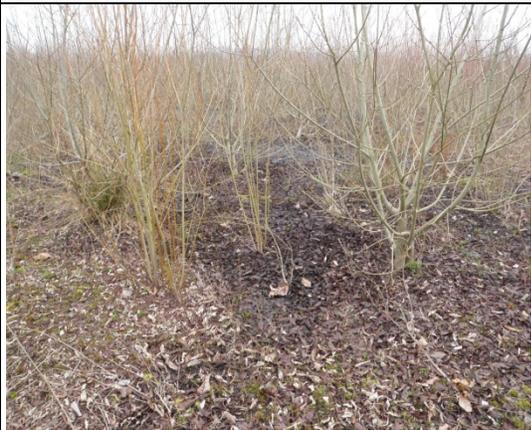
SR 20 Gages Slough Mitigation Site – Wetland Delineation Summary		
Total Delineated Wetland Area	11.7 acres (11.1 PEM/PSS, 0.6 PAB/POW)

A Global Positioning System (GPS) Trimble GeoXT mapping grade unit was used to record the wetland boundaries and sampling point locations (Figure 2). Wetland boundary points were recorded at regular intervals and at any change in direction along the boundary.

Wetland polygons, sampling point locations, and wetland names shown in Figure 2.
